TECHNICAL REPORT REMR-CO-3

CASE HISTORIES OF CORPS BREAKWATER
AND JETTY STRUCTURES

Report 2

SOUTH ATLANTIC DIVISION

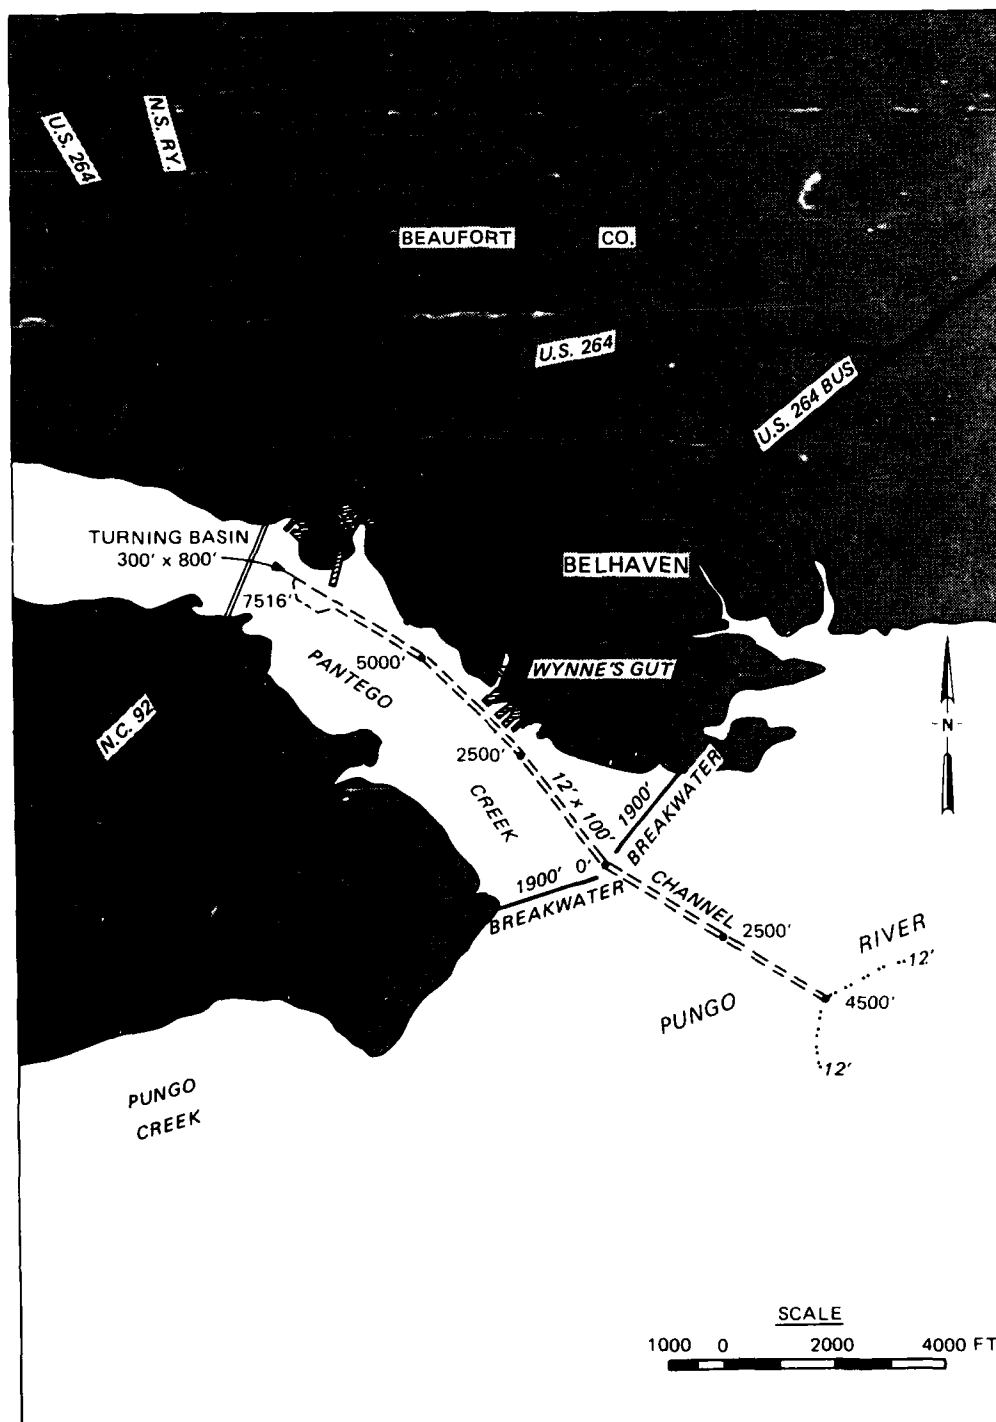
Figure 5. Belhaven Harbor, North Carolina

1982	Visual examination showed that approximately three dozen timbers were missing over the length of the breakwaters. Also, a few pilings were missing. It was thought that the damage resulted from the impact of transient barges tied to the structure.
1985	The structure does not provide its intended wave protection, but at present there are no plans for improvement.
